Effects on Fatigue of Applying Titanium Nitride Coating to 17-4 PH Stainless Steel

School of Engineering, College of Computing, Engineering & Construction, University of North Florida, Jacksonville, FL 32224

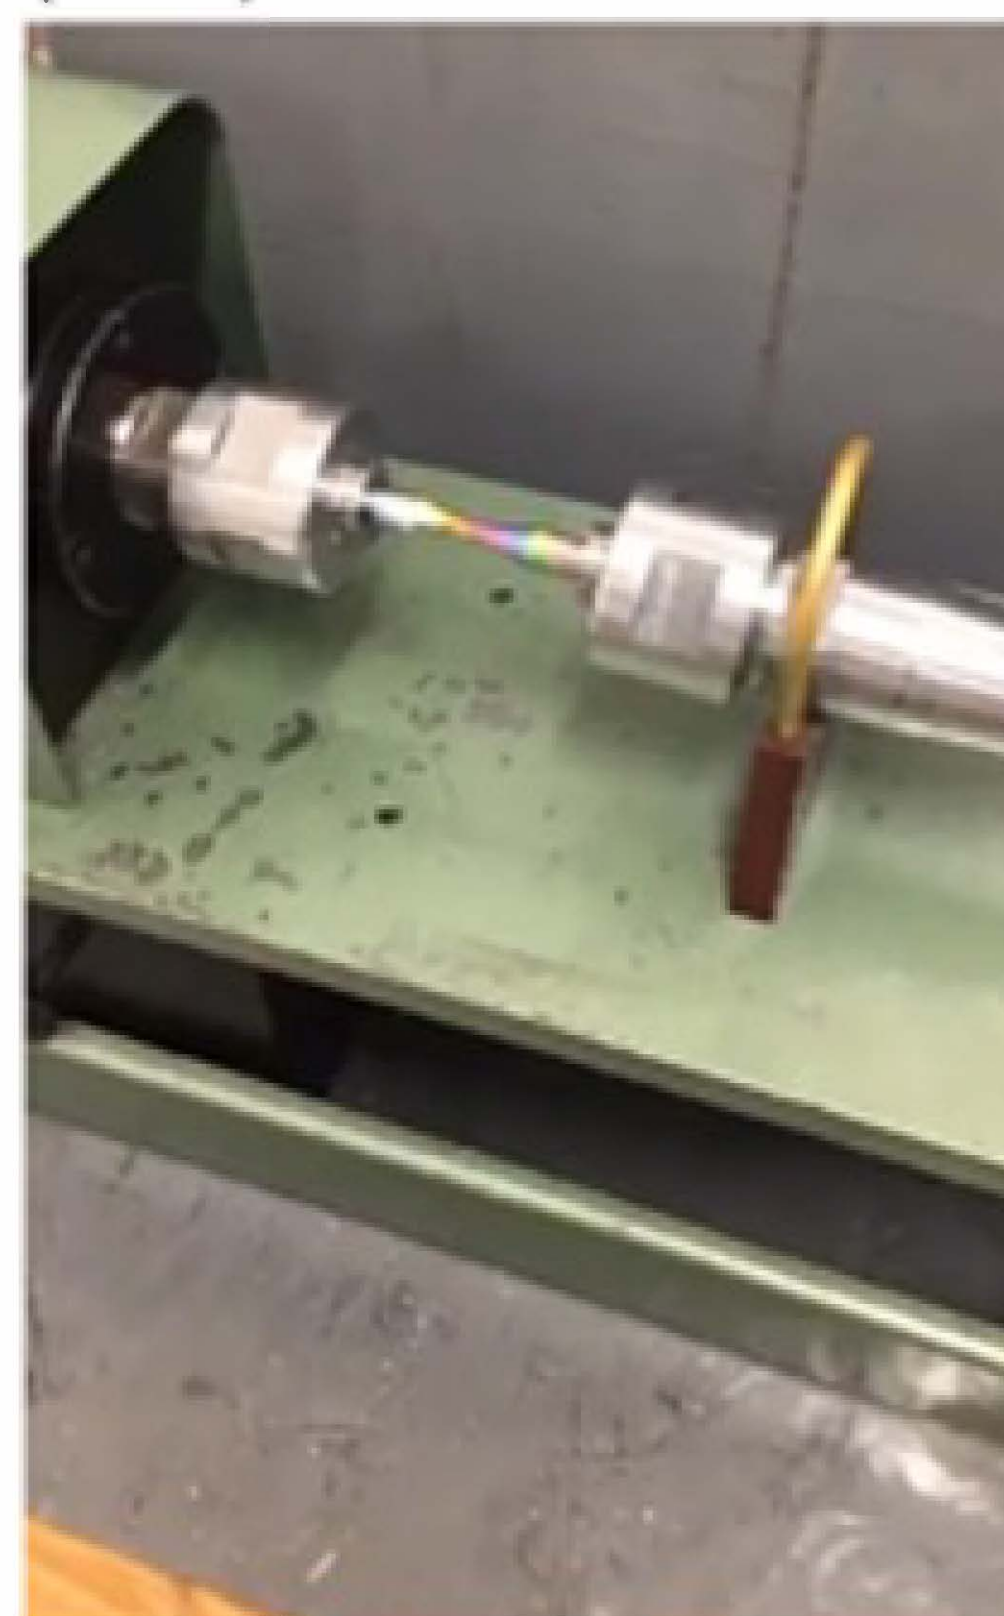
Test Setup

- Rotating-bending fatigue test
 - ⇒ RBF200 system (System Integrators, LLC)
 - ⇒ Cantilevered-type setup
 - ⇒ Constant frequency for all tests

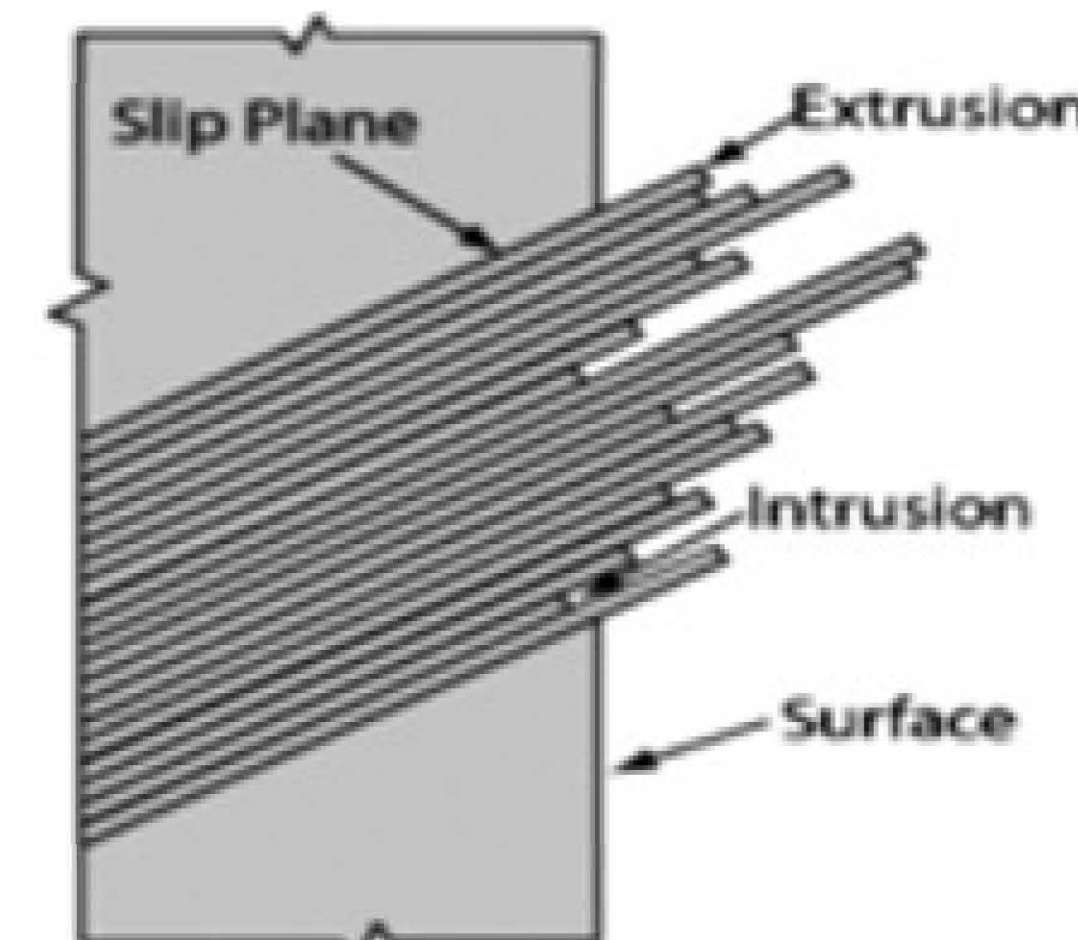
- Progressive movement of grains under cyclic loading can lead to extrusions or intrusions appearing at the surface.

Diagram of Extrusions/Intrusions Present at Surface

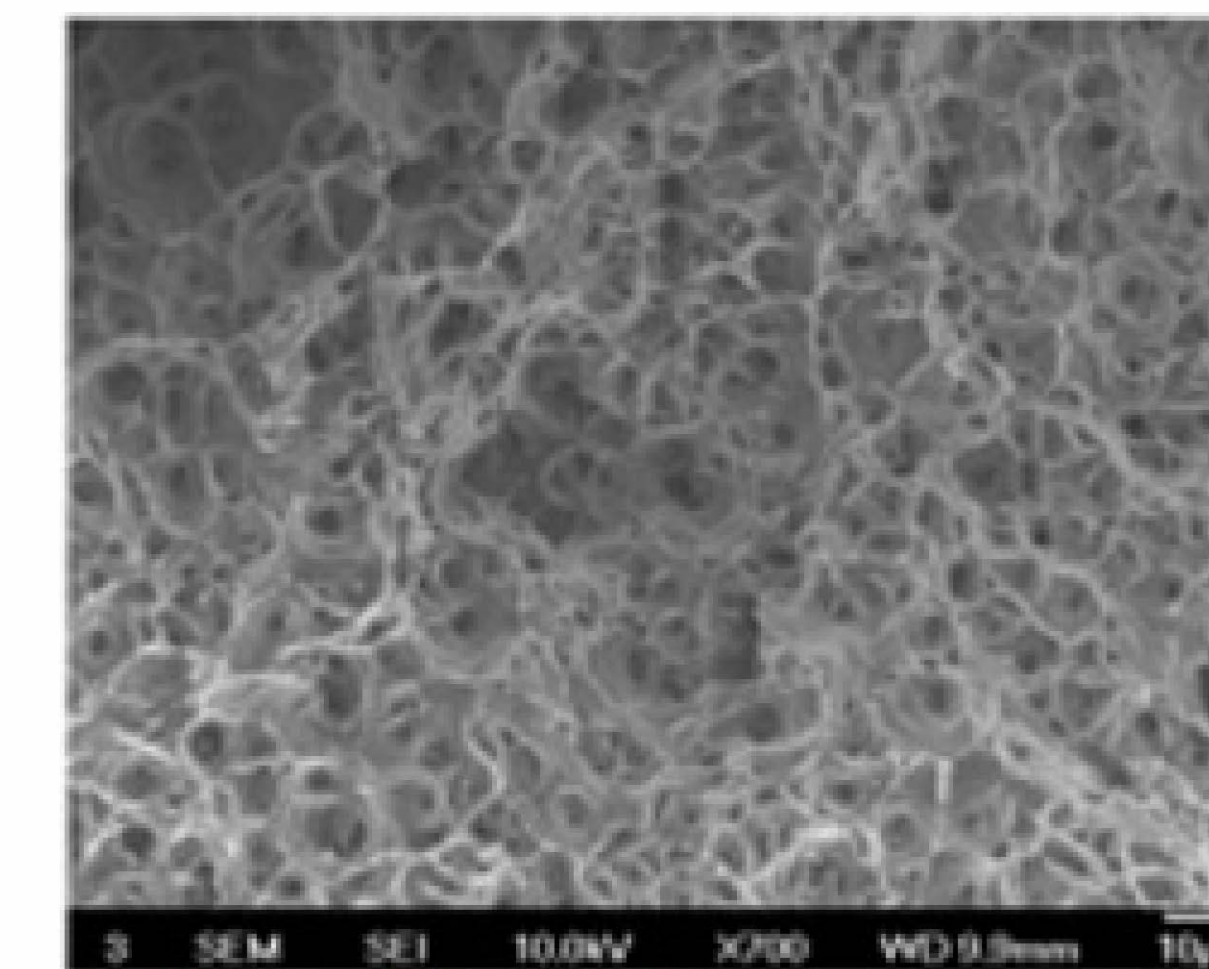
- A collection of microscopic voids may cause crack initiation to occur internally within the material.

A Representation of Microvoid Coalescence

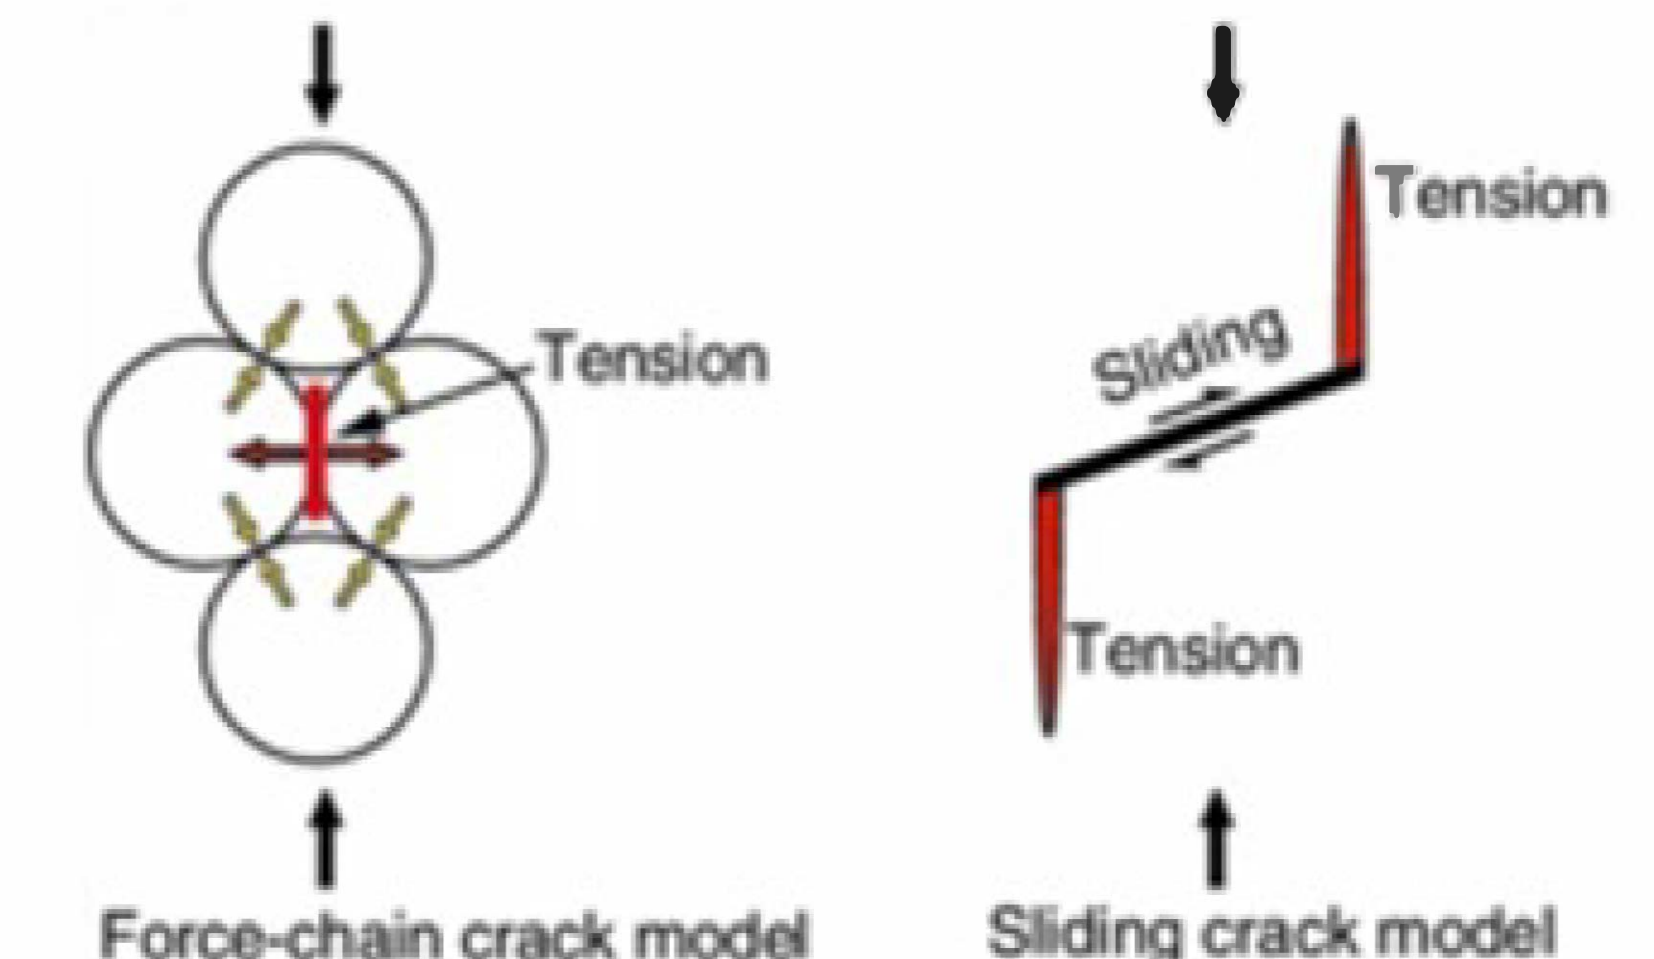
- Different directions of slip that grains can be subjected to will give varying modes of crack growth and initiation.

An Image of Microscopic Movements That Cause Internal Cracks to Form

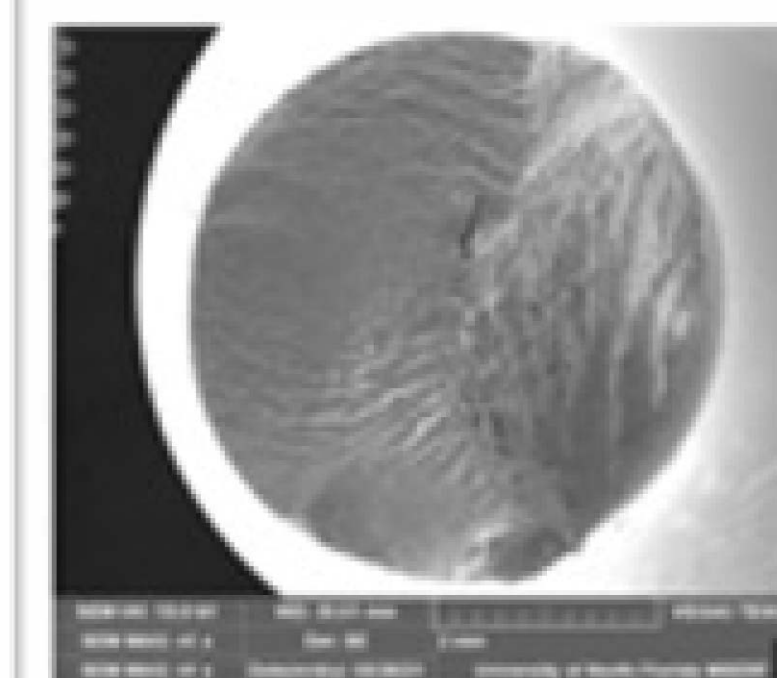
Fracture Surface of TiN Coated Specimen Tested at 650 MPa

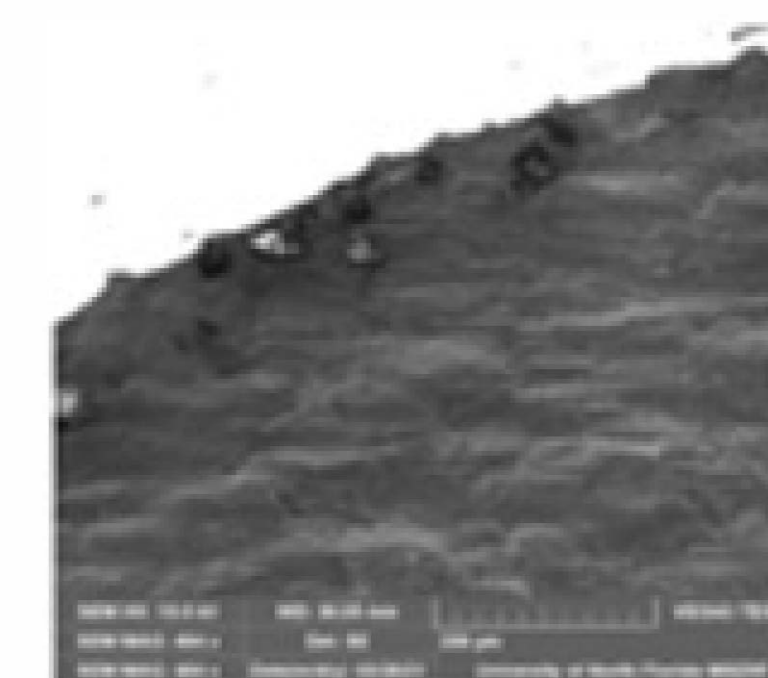
Crack Initiation Site of TiN Coated Specimen Tested at 650 MPa

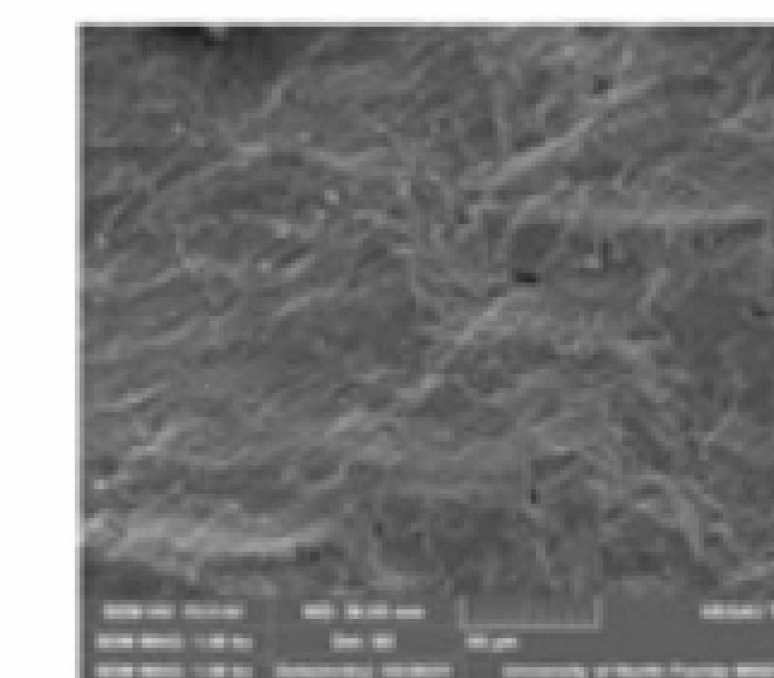
Striae on TiN Coated Specimen Tested at 650 MPa

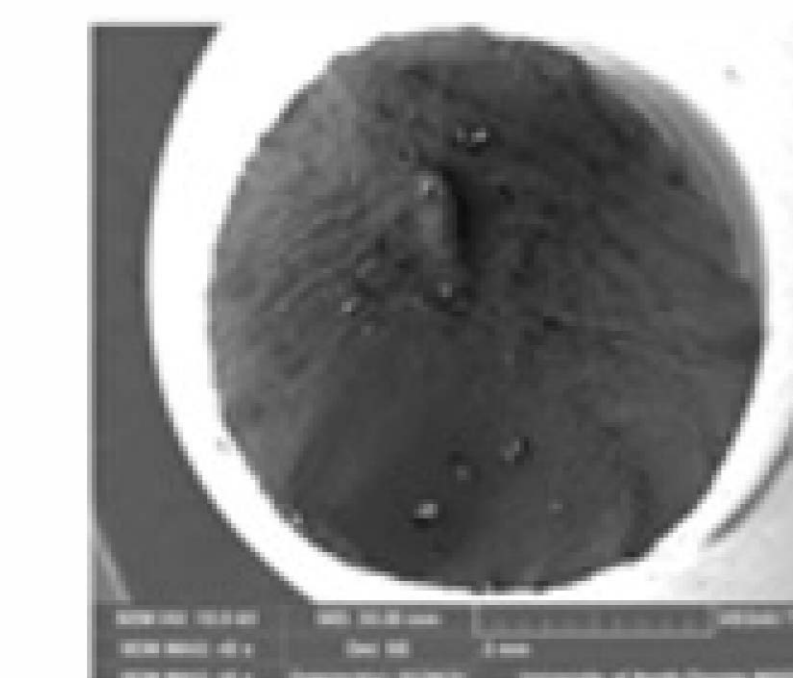
Fracture Surface of Wrought Specimen Tested at 650 MPa

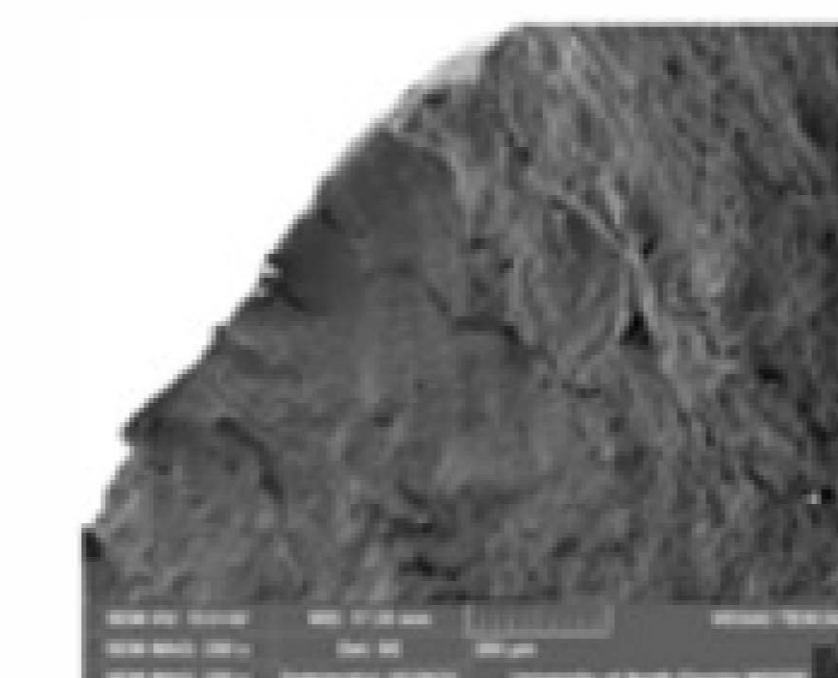
Crack Initiation Site of Wrought Specimen Tested at 650 MPa

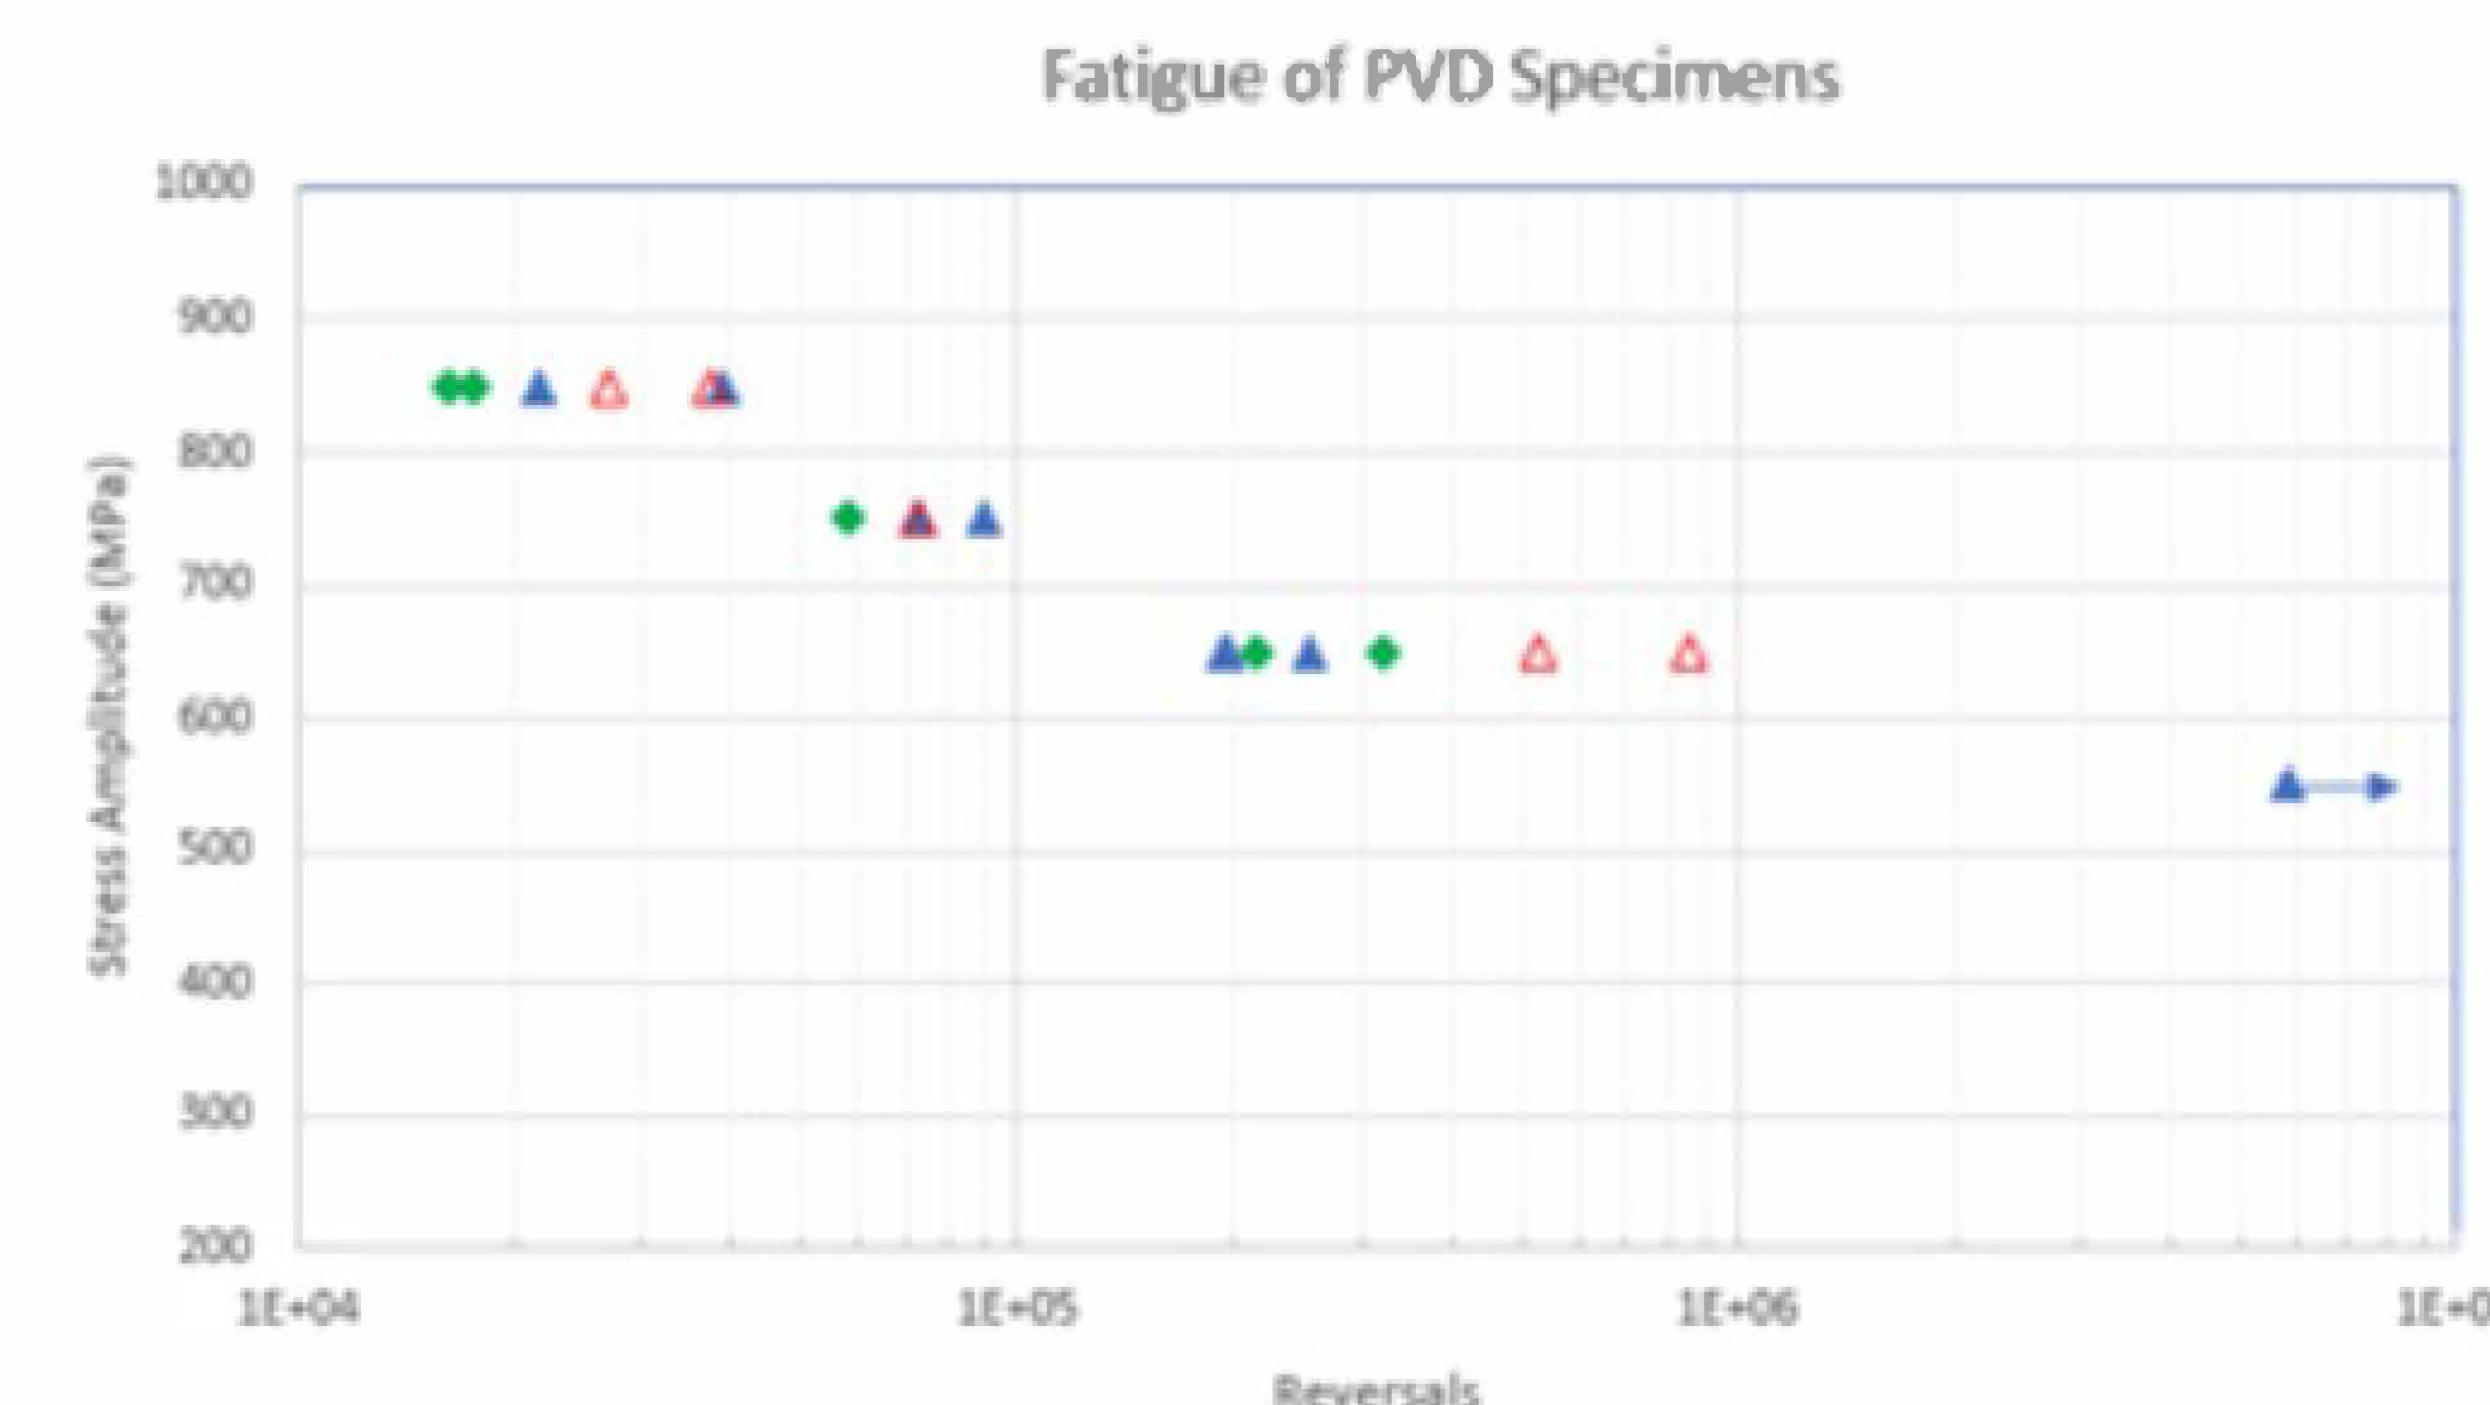
- Fatigue behavior of 17-4 PH SS

- ⇒ Specimens exhibited better fatigue strength under PVD coating for a duration of 2 hours.
- More than half an order of magnitude at higher stress amplitudes.
- Increase in fatigue resistance in not significant.
- ⇒ The specimens subjected to a PVD coat of 1 hour showed no substantial improvement to fatigue resistance.
- ⇒ A longer duration of the PVD coating process does show to have an effect on prolonging the life of the specimens.
- ⇒ This is most likely due to the fact that cracks initiate at the surface in both wrought and PVD coated specimens.

- The experimental results revealed some influence of surface hardness on fatigue resistance for 17-4 PH SS in the PVD condition.
- Results are currently inconclusive, further work will be performed to investigate the effects of surface hardness on the fatigue behavior of PVD coated specimens.
