## Flexural Behavior of Laterally Damaged Full-Scale Bridge Girders Through the Use of Carbon Fiber Reinforced Polymers (CFRP)

**FLEXURAL BEHAVIOR OF Laterally Damaged Full-Scale Bridge  
Girders through the Use of Carbon Fiber Reinforced  
Polymers (CFRP)**

Master of Science in Civil Engineering

UNIVERSITY OF NORTH FLORIDA

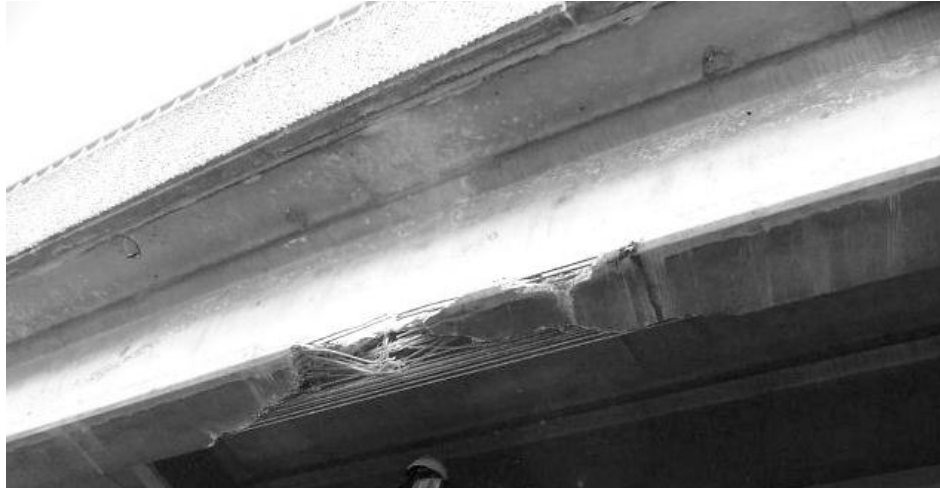
Figure 1.1 – Example of impact damaged bridge girder provided by the Washington State Department of Transportation (WSDOT)

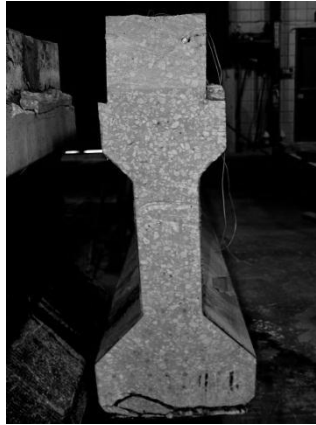
Figure 3.3 - Picture of specimen cross section

184.35 with a top section modulus of  $3261.72 \text{ in}^3$  and a bottom section modulus of  $4140.23 \text{ in}^3$ . Figure 3.3 shows the cross section for each of the test specimens with the composite topping.

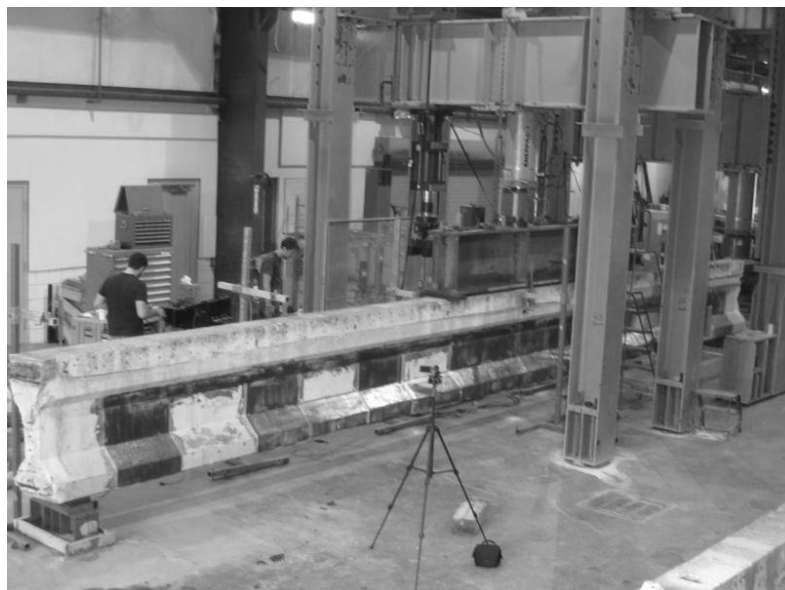
Figure 3.8 – Picture of the testing setup in the FDOT structures lab

The test girders are supported by rubber bearing pads placed on top of steel beams. The steel girders were placed in a rectangular shaped block made out of mortar which was on top of the floor of the lab. This rectangular block of mortar was made in order to spread the stresses caused by the loading of the machine across a larger area of the floor so that no damage was done to the floor of the lab. Figure 3.8 shows a picture of how the test girders were set up for testing in the FDOT structures lab in Tallahassee, FL.

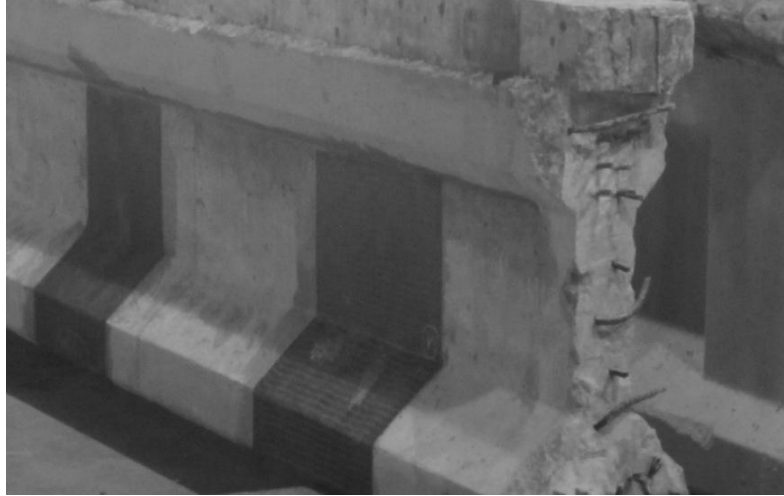
Figure 3.11 – Example of different U-wrap widths for girder 6

Each of the girders had been repaired with different configurations in order to find the effectiveness of each. There were two control specimens, girders 4 and 8, which were tested statically to failure for comparative measures. Girder 8 was undamaged without any CFRP added and girder 4 had simulated damaged done with only an epoxy injection and mortar repair, but no CFRP added. The other three girders were damaged and repaired with different CFRP configurations. Girder 6 used a combination of two different CFRP sheets because there was a shortage of the Fyfe brand material which made for a different spacing of U-wrappings because the width of the BASF material was less than that of the Fyfe material. Figure 3.11 illustrates the different U-wrap widths for the different products uses with the Fyfe material on the right side which is 24 inches and the BASF material on the left which was 20 inches in width.
