Corrosion of Post-Tensioned Tendons Repaired with Dissimilar Grout

CORROSION OF POST-TENSIONED TENDONS REPAIRED WITH DISSIMILAR GROUT

Masters of Science in Civil Engineering

UNIVERSITY OF NORTH FLORIDA

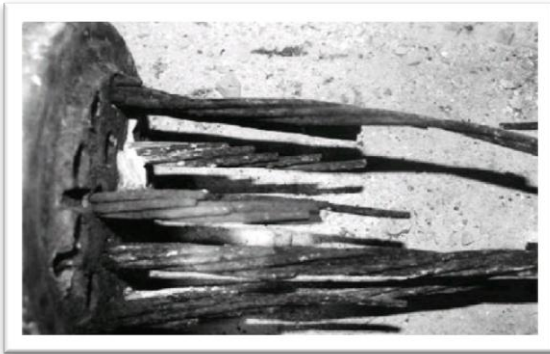
Figure 2.3 Advanced Corrosion of Strands within Niles Channel Bridge Tendons (FDOT, 2002a).

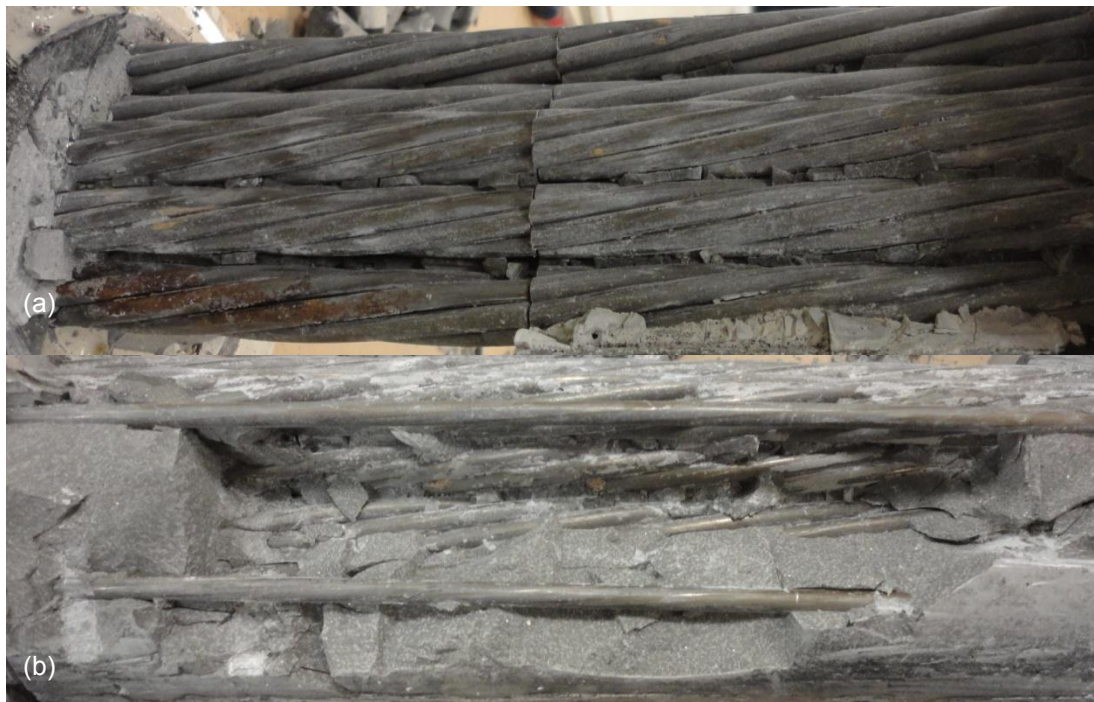
Figure 4.31 Strand embedded in existing grout after testing. (a) Sample FS1 with corrosion manifestation, (b) Sample FS2.

After performing an autopsy of the samples on Test Setup FS, the manifested corrosion was associated to a localized pocket of white/chalky grout located at the edge of the pre-existing void, and shown in Figure 4.30. The corrosion was thought to begin after introduction of excess moisture from the repair grout into the crevice area formed by the cracks in the existing grout. The surface of the steel wire embedded in the repair grout did not show any appearance of corrosion after autopsy and final examination of the samples, as evident in Figure 4.31a and 4.31b.

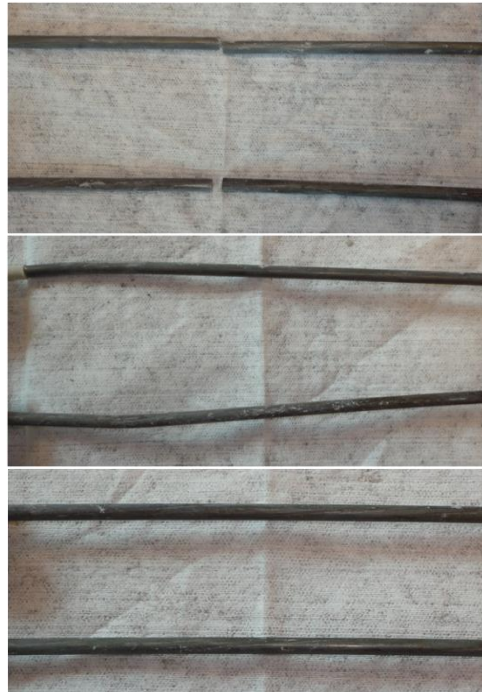
Figure 4.43 Autopsy of Test Setup S.

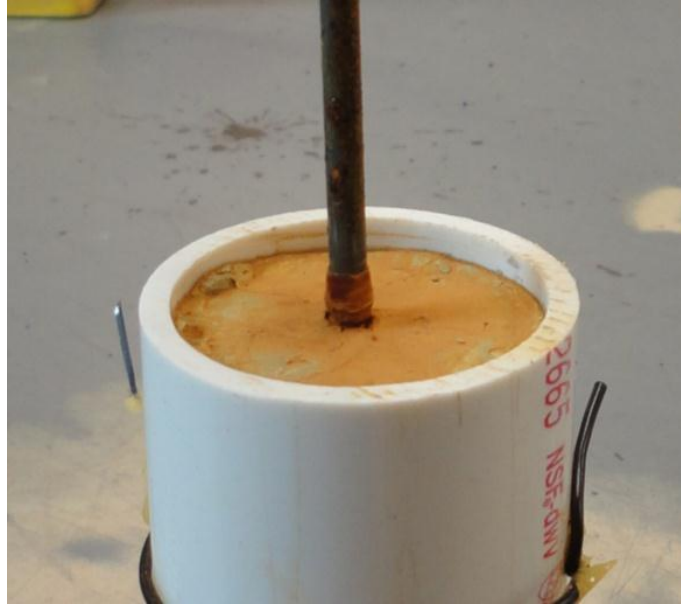
Figure 4.49 Accumulation of rust at base grout interface after exposure to 100% humidity for a period of 30 days (Test Setup B).
