## Bridge Deck Cracking Investigation and Repair

BRIDGE DECK CRACKING INVESTIGATION AND REPAIR

Master of Science in Civil Engineering

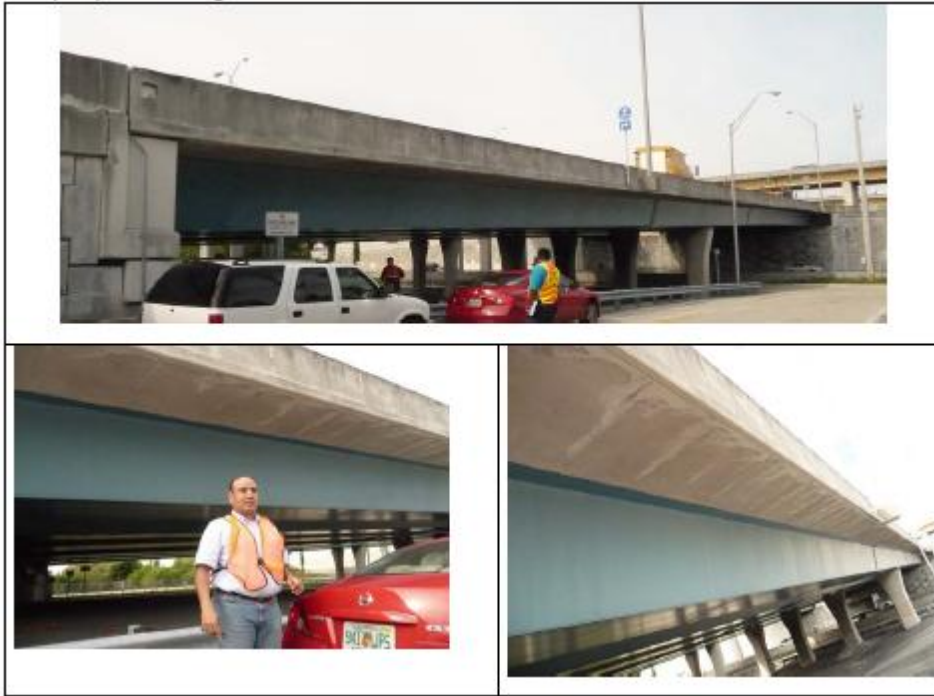
**Figure 1-1 Bridge 860524 Deck Cracking**

As for the 860524 bridge in Fort Lauderdale a total of 19 cracks were found on the top-side of the deck as well as 44 was found on the exterior bottom side of the deck. The average crack widths for the cracks documented on this bridge ranged between 0.254mm and .5mm (.01 and .0197 in). The lengths of the aforementioned transverse cracks ranged from 3 feet to 36 feet and getting smaller in sections close to the parapet walls.

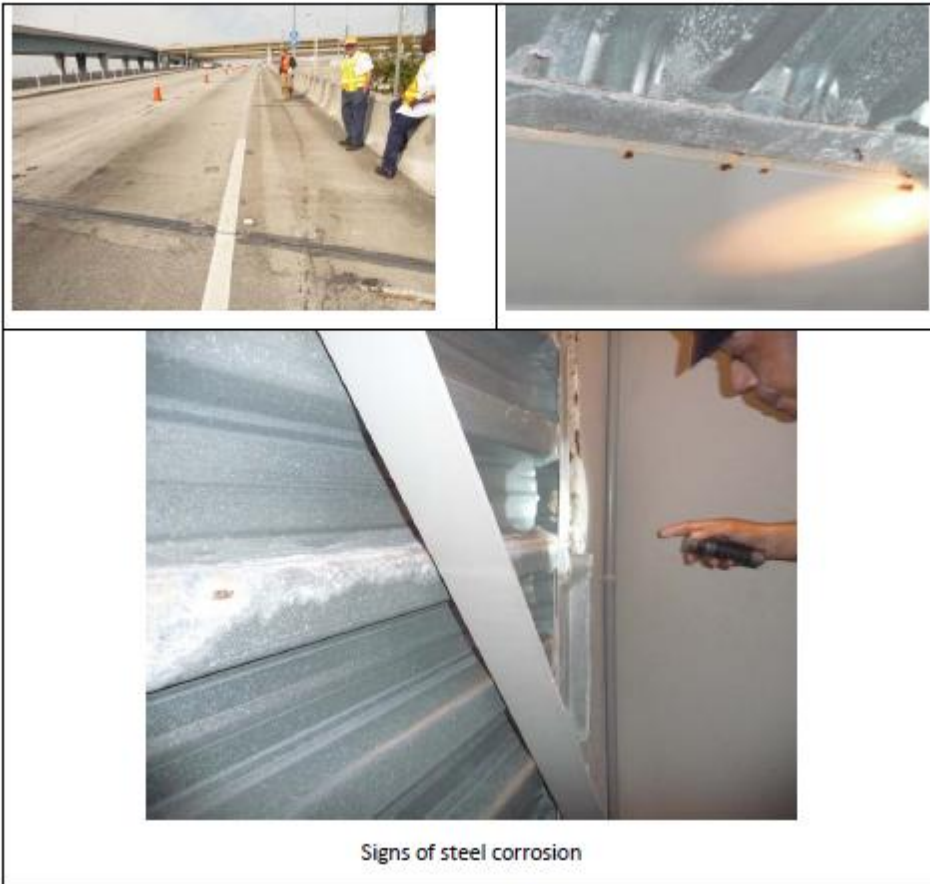
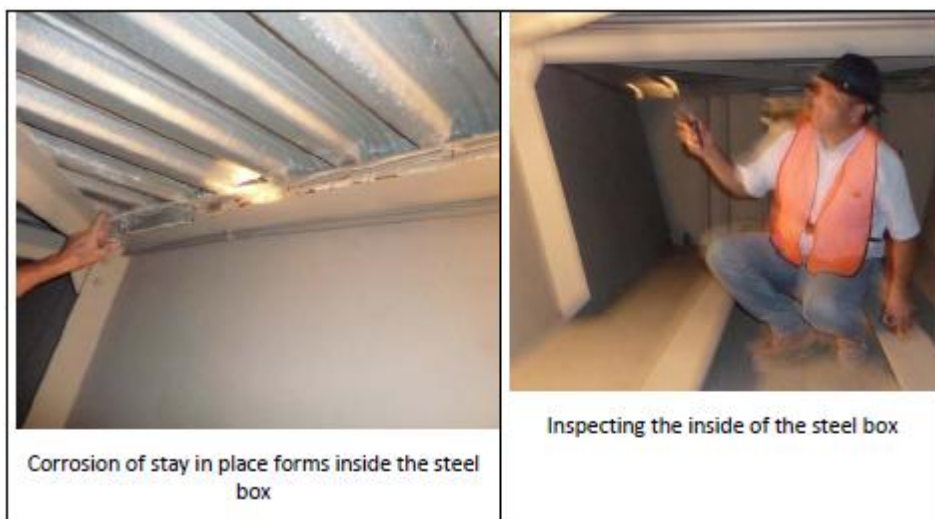
**Figure 1-2 Corrosion Inside Box Beams Bridge 860524**

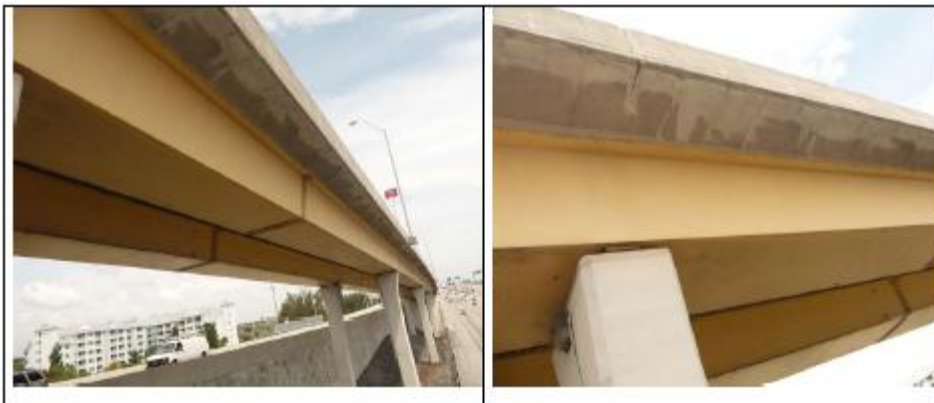
Figure 1-3 Bridge Deck Cracking on Bridge 860526

Similar crack patterns to bridge 524 were found to exist on the 526 bridge. Cracks evident on the deck of this bridge had already been repaired therefore some of the documentation was impaired by the presence of epoxy and methacrylate sealants. The average visible crack widths still able to be measured were .304 mm (.012 in).

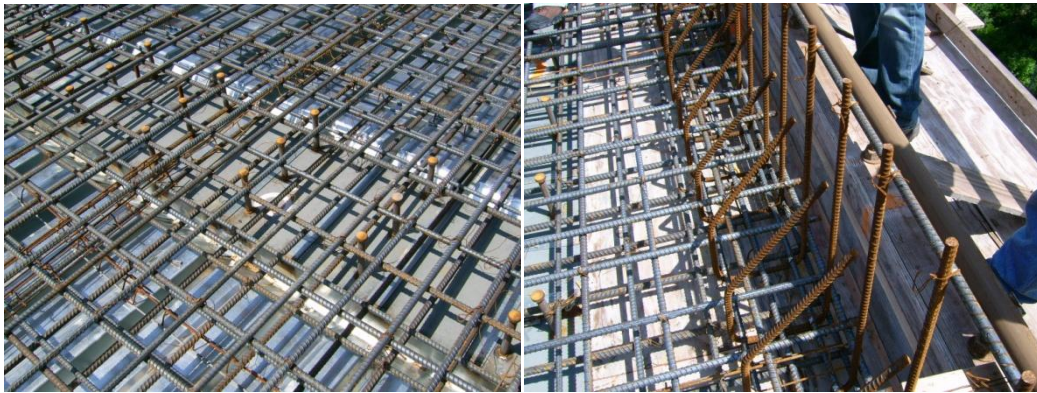
**Figure 1-8 Reinforcement on Bridge 780121**

We were fortunate to be able to track this bridge from the beginning, from reinforcement application to concrete placement. The procedures for concrete placement and curing were followed as advised by many researchers with finishing of the concrete within 20 minutes of placement and a wet curing time of 10 days however even with proper procedures the bridge deck began to show signs of transverse cracking within 30 days of concrete placement with 14 cracks appearing on day 26.

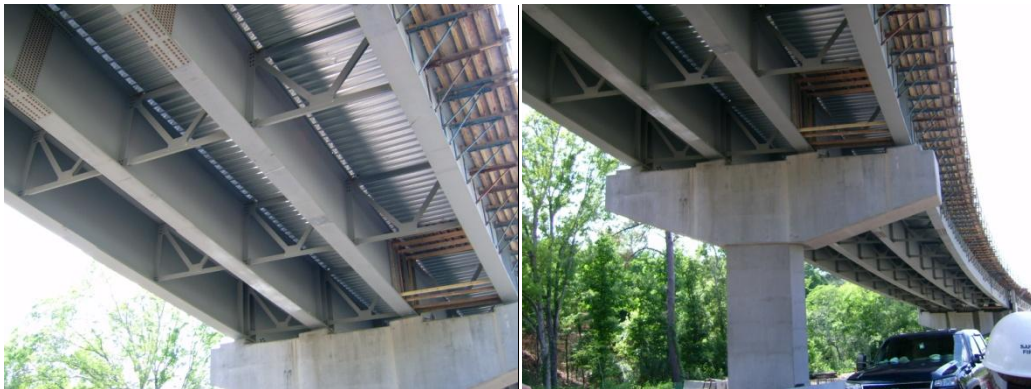
**Figure 1-9 SIP Forms for Bridge 780121**

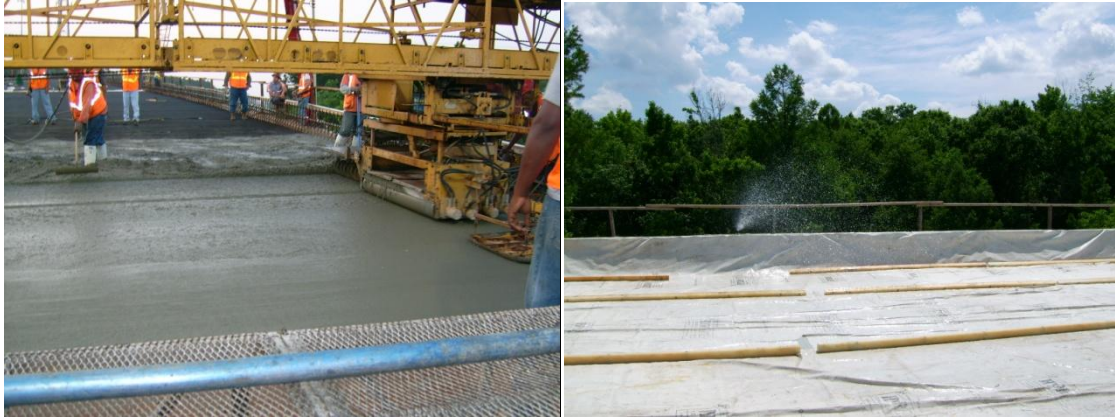
**Figure 1-10 Concrete Placement and Curing for 780121**

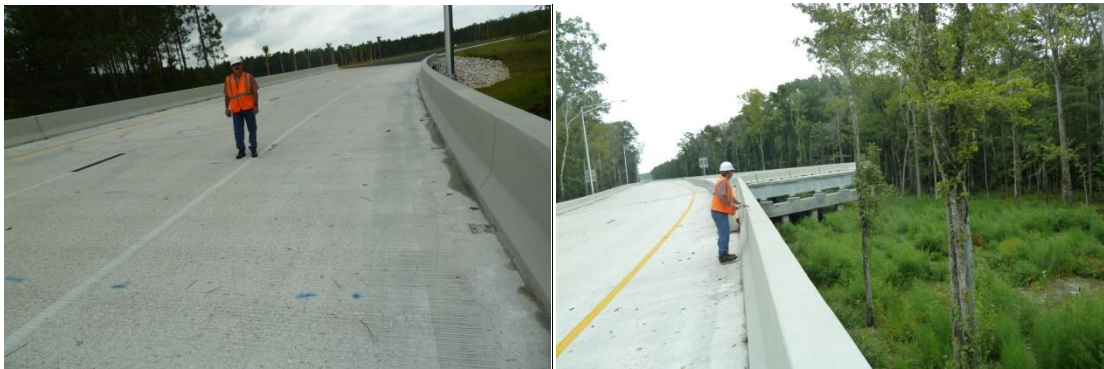
Figure 1-13 View of Bridge 780122

This is a prestressed girder bridge with 14 spans that showed no signs of transverse cracking throughout its construction, however during the placement of the last span the concrete provider had to be replaced and the new concrete that was placed began cracking 36 days after placement. The compression test of the concrete was 7477 psi which again verifies the conclusion of many researchers that high compression concrete has a higher propensity for transverse cracking.

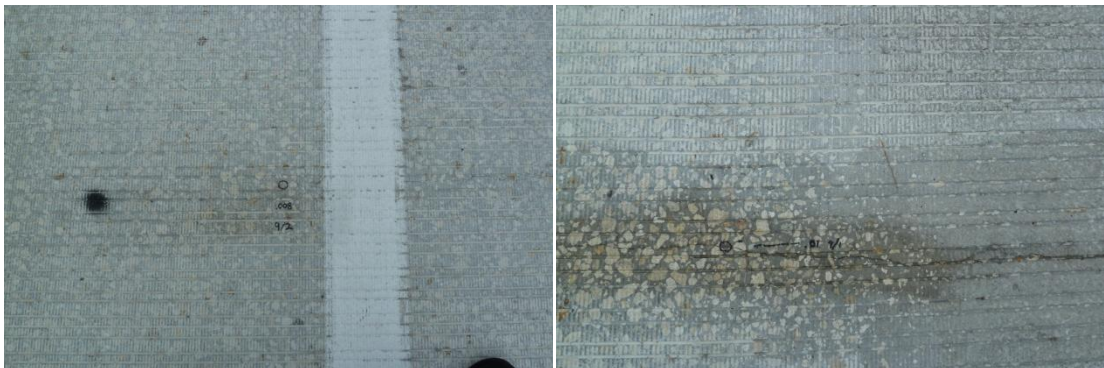
Figure 1-14 Deck Cracking and Sealing of Bridge 780122

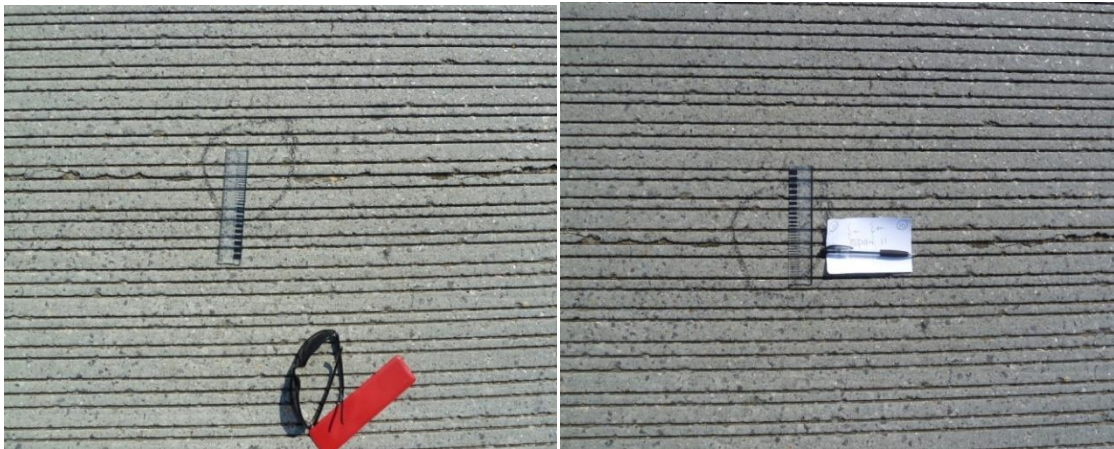
Figure 1-15 Transverse Cracking of Bridge 580167

This bridge is a 16 span steel girder bridge that developed severe transverse deck cracking and is the bridge used for the field test of the sealers. Most of the cracks on the bridge developed around the transverse rebar and ran all the way across to the parapet wall.

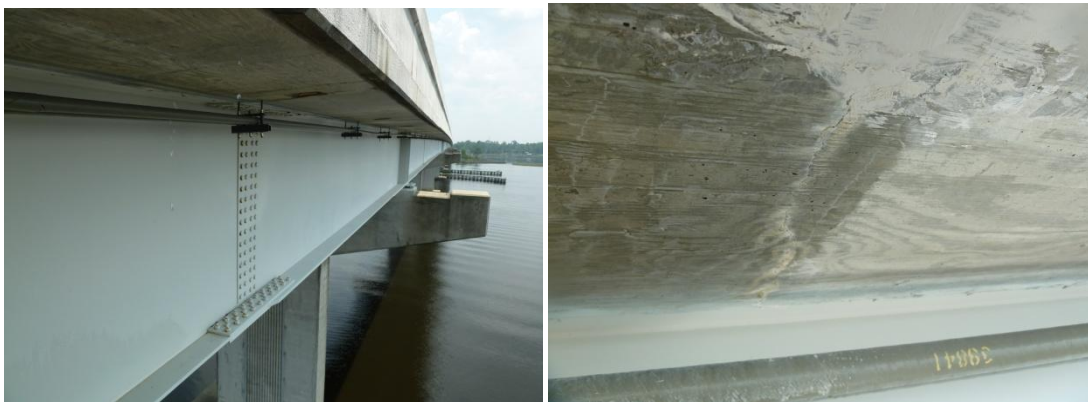
Figure 1-16 Cracking on Parapet Wall Bridge 580167

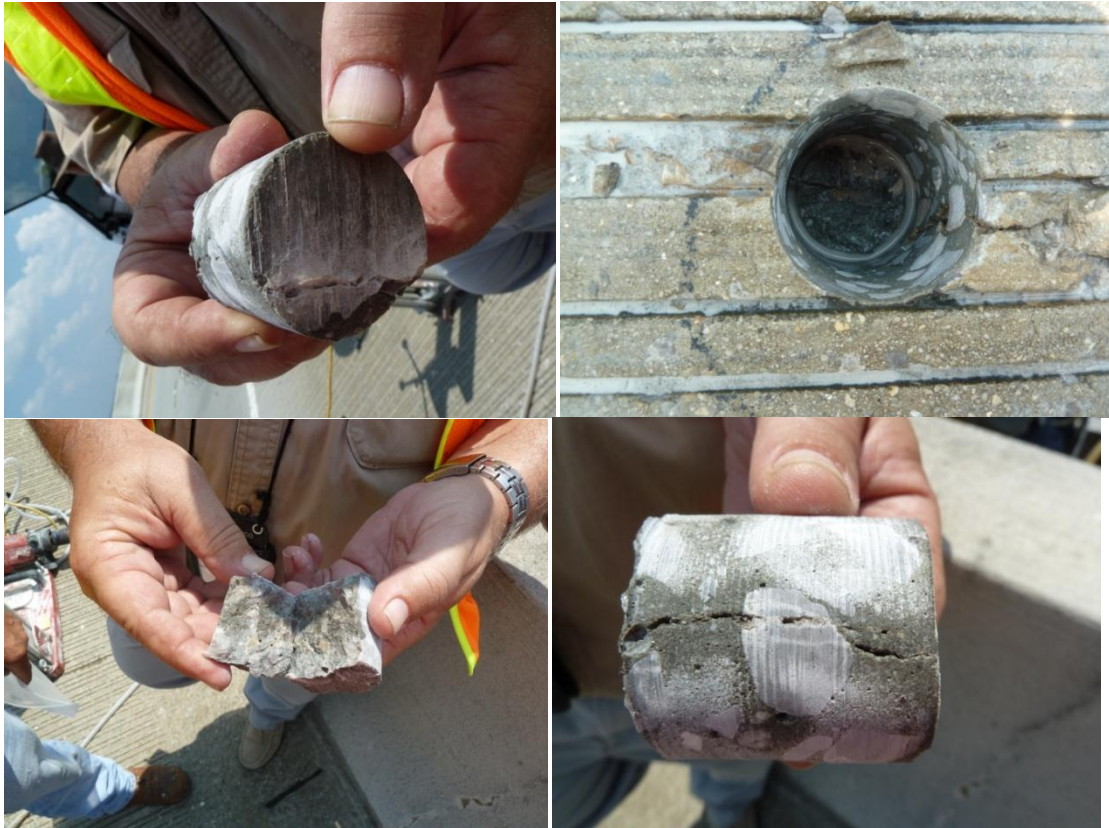
**Figure 1-17 Core Sampling of Bridge 580167**

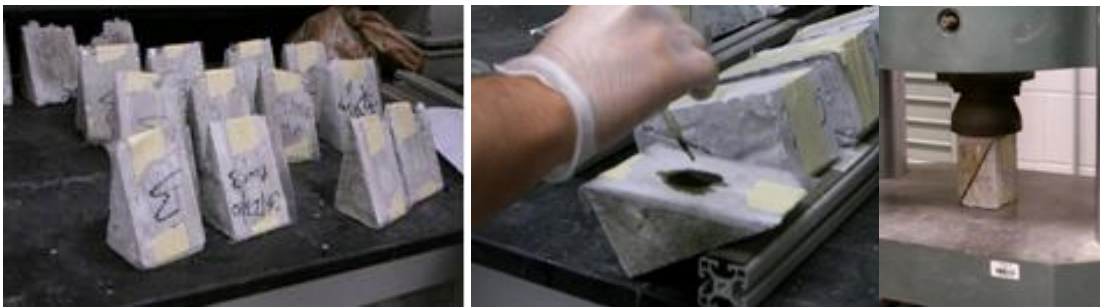
**Figure 4-2 Applying the Sealant to Concrete Specimens and Testing**

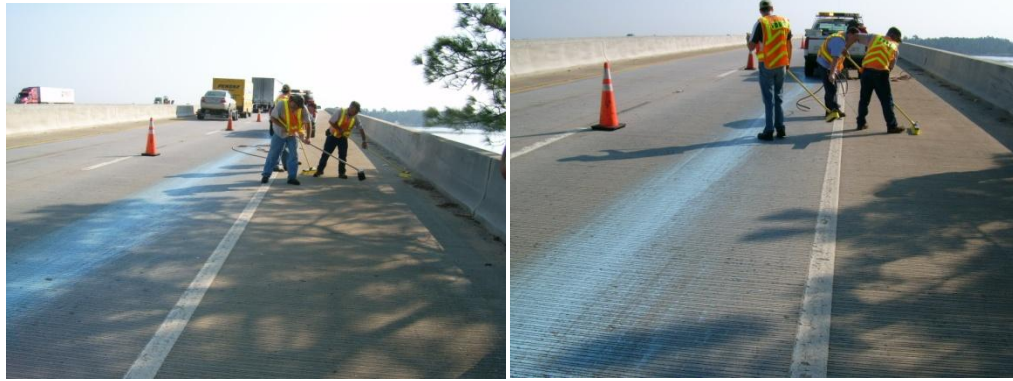
**Figure 4-4 Clean-up of Bridge 580167**

The surface was prepared, the cracks were cleaned properly by the FDOT, the sealant materials were applied according to the specified procedure in the manufacturer's data sheet, and sand was sprinkled to provide skid resistance. Table 4-5

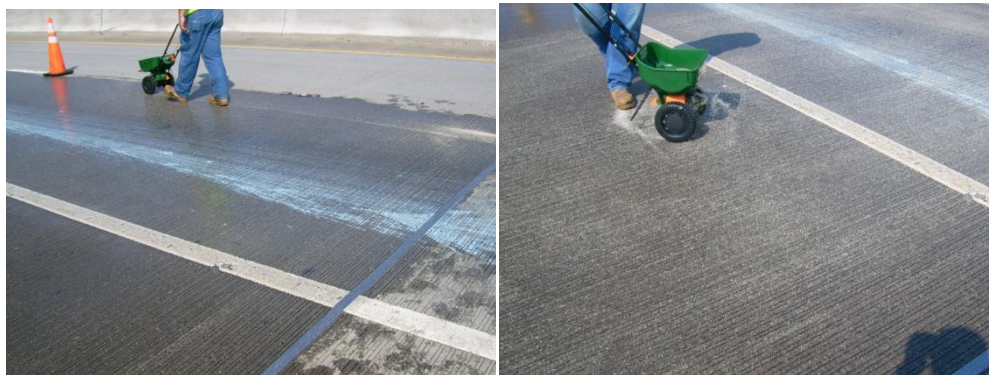
**Figure 4-6 Sand Application for Skid Resistance Bridge 580167**

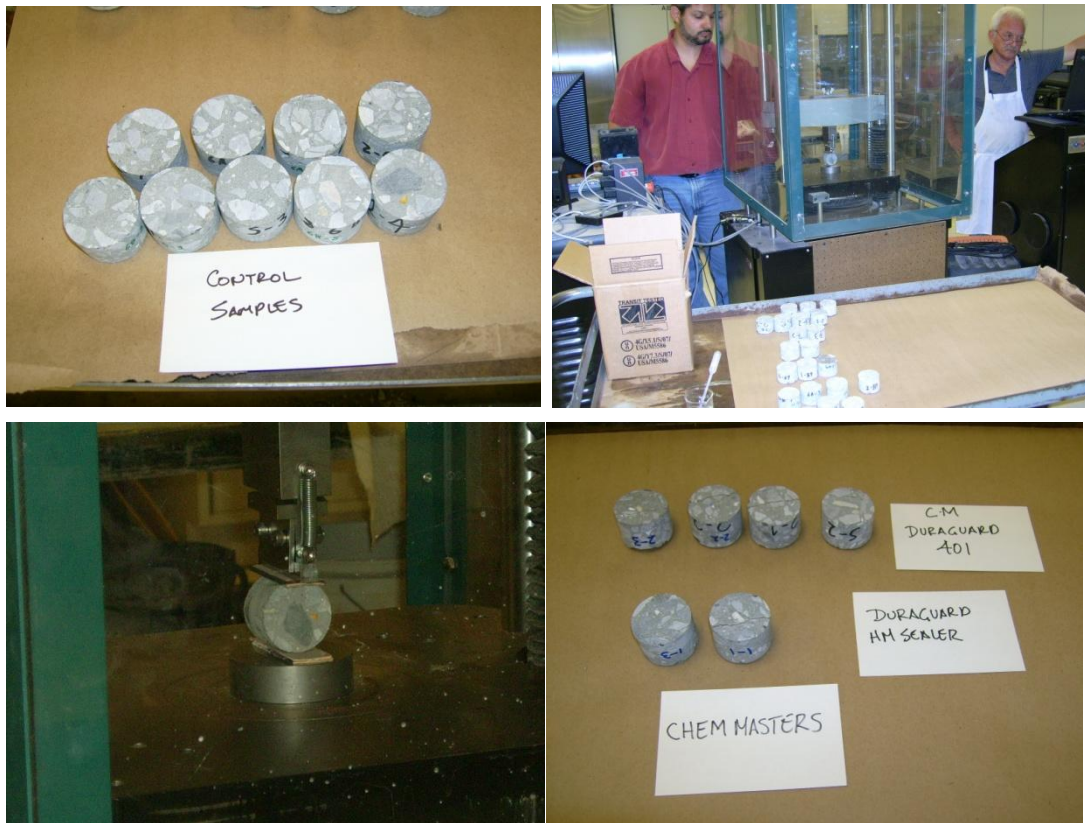
**Figure 4-7 Bridge 580167 Cores and Testing Procedure**

shows the field test results for the five sealants applied to parts of the same bridge. The deck surface was allowed to dry for the indicated time of each product. Core samples were taken, after curing of the sealant, at random locations of each test area and tests were performed in accordance to ASTM C-496 at the FDOT laboratory facilities. The cores and testing procedure is shown in Figure 4-7.

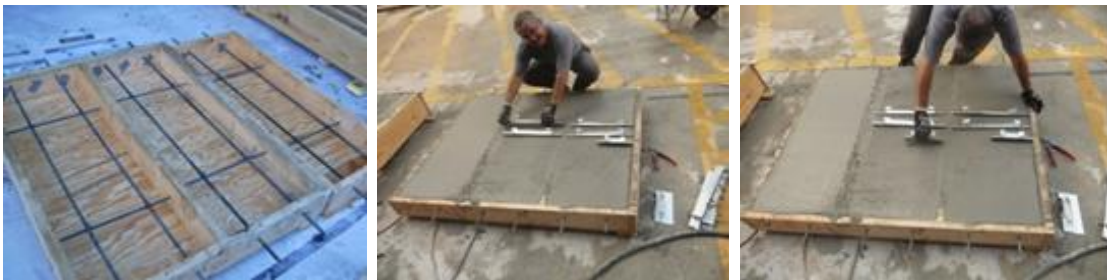
Figure 4-11 Construction of Test Slabs and Placement of Blades for Crack Width

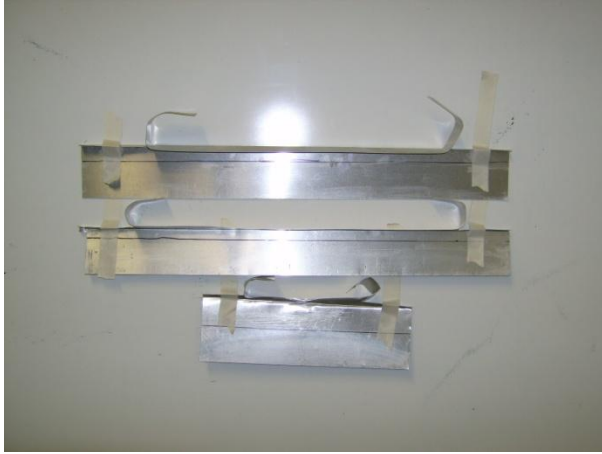
**Figure 4-12 Blades Constructed for Ideal Cracks**

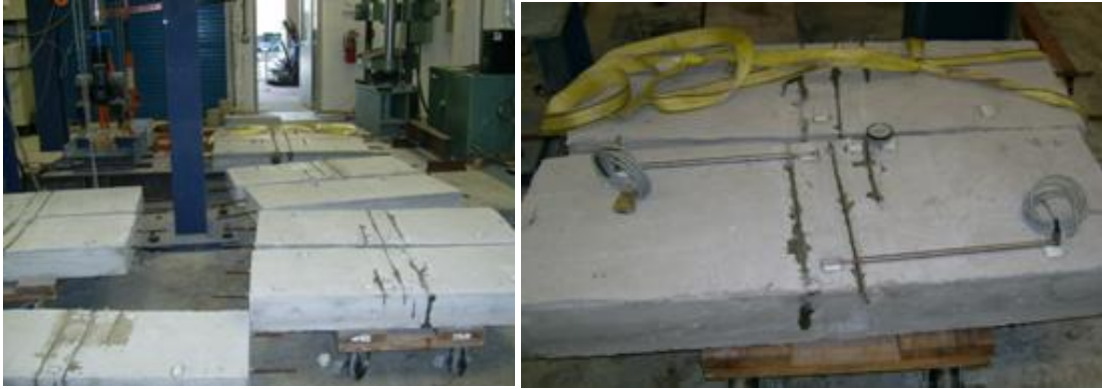
**Figure 4-15 Sealed Slabs with LDVT's and Dial Gage**

The cracks on the rest of the slabs were sealed with the appropriate sealer, as shown in Figure 4-15 and allowed to cure for several weeks. During that time we devised a way to test the slabs upside down (cracks facing up) so as to simulate the cracking on a continuous bridge where the cracks appear on the top surface of the opposite span from where the load is applied. Another reason was to observe the crack behavior under the load during the test. To accomplish both of these goals we built a spreader bar and two different point load bars with the single point load shown in figure 4-16.

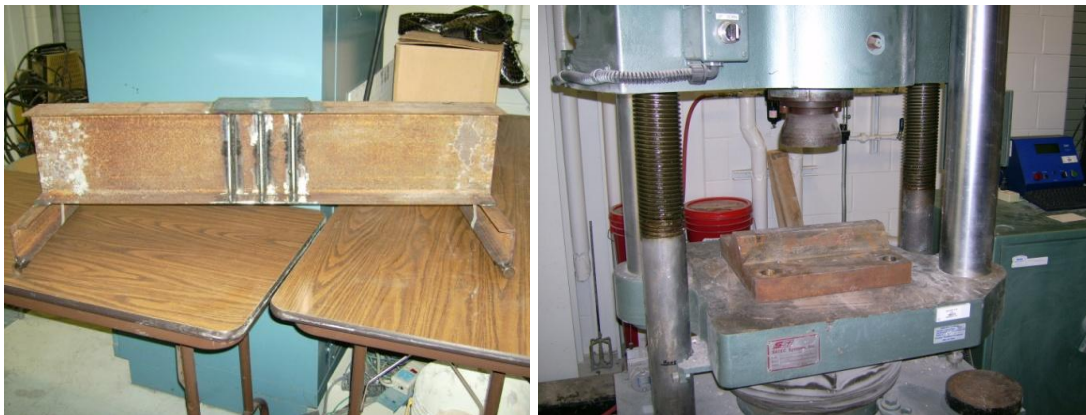
**Figure 4-16 Spreader Bar and Single Point Load Bar**

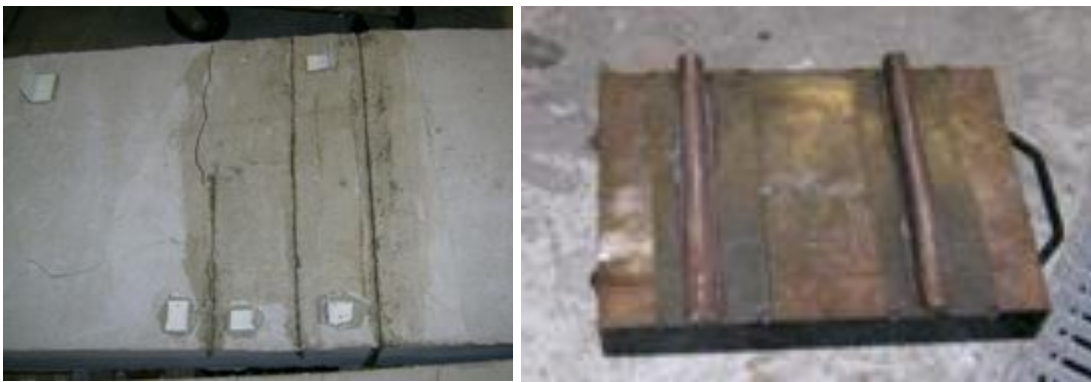
**Figure 4-19 Slab 1-A Crack Propagation and Double Point Load Plate**

moment diagram of a single point load the maximum stress occurs at the center with variable stress to the sides. Therefore, a second test with two point loads was performed, this makes the moment diagram take the shape of a flat top pyramid, whereas the outside crack propagated but no visible sealant debonding as shown in Figure 4-19 which also shows the two point load bar constructed for the test. The test results are shown in Figures 4-20 and 4-21.
