The Repair of Laterally Damaged Concrete Bridge Girders Using Carbon Fiber Reinforcing Polymers (CFRP)

Master of Science in Civil Engineering

UNIVERSITY OF NORTH FLORIDA

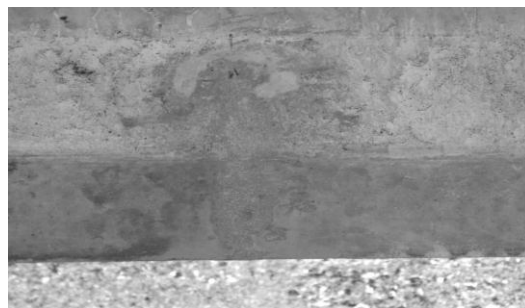
Figure 3-7: Finished repaired section

cut was then thoroughly cleaned with a water jet and pressurized air. The cleaned opening was filled with a high strength cementitious repair mortar and a high pressure epoxy injection procedure was performed after the mortar set (Figure3-6). The procedure resulted in a near perfect repaired cross-section, as seen in Figure 3-7.

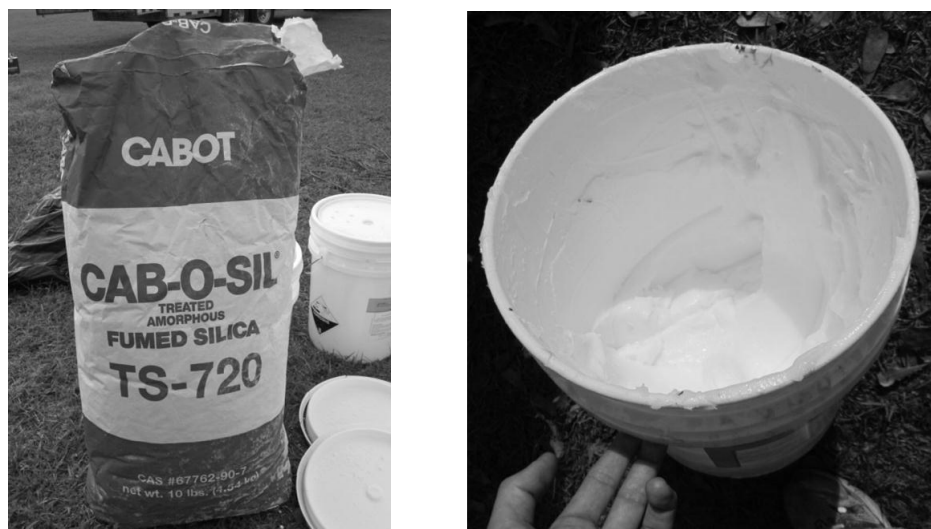
Figure 3-14: (left) Fumed Silica used to Thicken Epoxy; (right) Thickened Epoxy

For the prestressed concrete girders, employees of Fibrwrap® performed the installation procedure for the ten statically tested samples in which a traditional wet lay-up procedure was implemented. Their crew first took grinders to the entire surface below the top flange of the girders. Next pressurized air was used to blow the concrete dust from the surfaces and a pressure washer was used to clean the girders. After drying in the sun, pressurized air was blown over the girders again and they began to mix the epoxy. Each portion of the epoxy was split and half was mixed with a substantial amount of Cab-o-Sil® fumed silica in order to gain a more desirable consistency. Figure 3-14 shows the silica product and the resulting thickened epoxy.

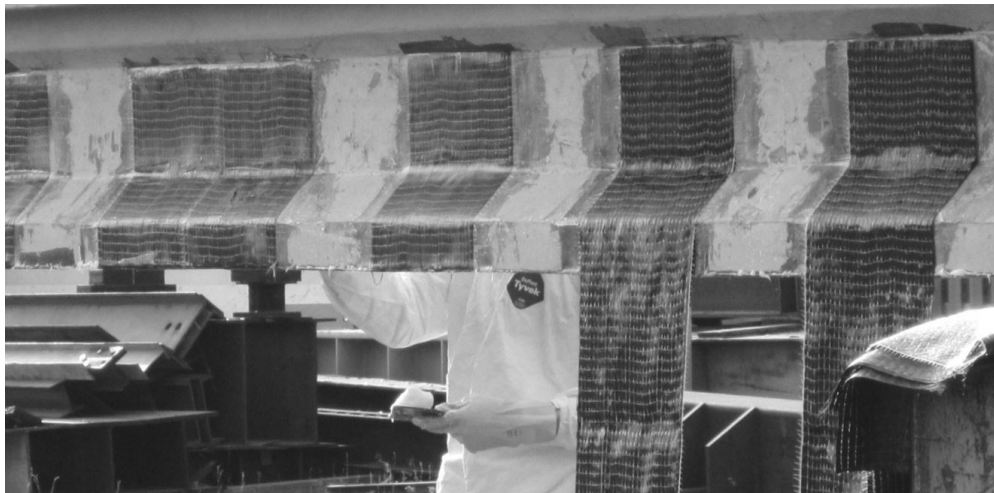
Figure 3-15: Transverse CFRP U-wrappings being applied by FIBRWRAP

Using the original thinner Tyfo® S epoxy a layer was rolled onto the concrete surface of the girders where the CFRP laminates would be applied. A thin layer of the thickened epoxy, containing the fumed silica, was then applied to the tension side of the girders and the first pre-cut longitudinal laminate, saturated in un-thickened epoxy, was attached. Trowels and paint rollers were used to remove any air voids once the first layer was adhered. Next, a second layer of the thickened epoxy was applied on top of the first laminate layer. At this point any required subsequent longitudinal layers were applied in the same manner. This procedure was identically followed for each layer of transverse U-wrapping applied with one added important process. To attach the transverse laminates all bonding procedures were performed on one side first while the remaining fabric hung towards the ground. Then with one side secure, the laminates were pulled tightly to ensure effectiveness as they wrapped around the cross-section. Figure 3-15 provides a moment of the process.

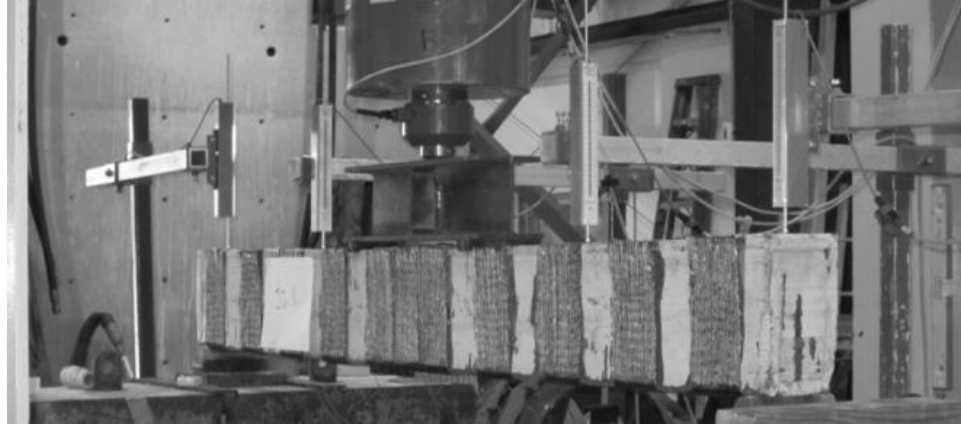
Figure 3-16: Example of Testing Setup for RC beams

The beams were instrumented with two laser deflection gages, four linear variable differential transformer (LVDT) deflection gages, and between 4 to 7 strain gages (30 mm long- 120 ohm). The two laser deflection gages were positioned at the center of the beams' span both above and below each beam. Two of the LVDTs were placed on the beams' top surface above the supports and the remaining two LVDTs were placed

on the beams' top surface at quarter points of the beams' span. Figure 3-16 displays a picture of the testing setup for the RC beams.

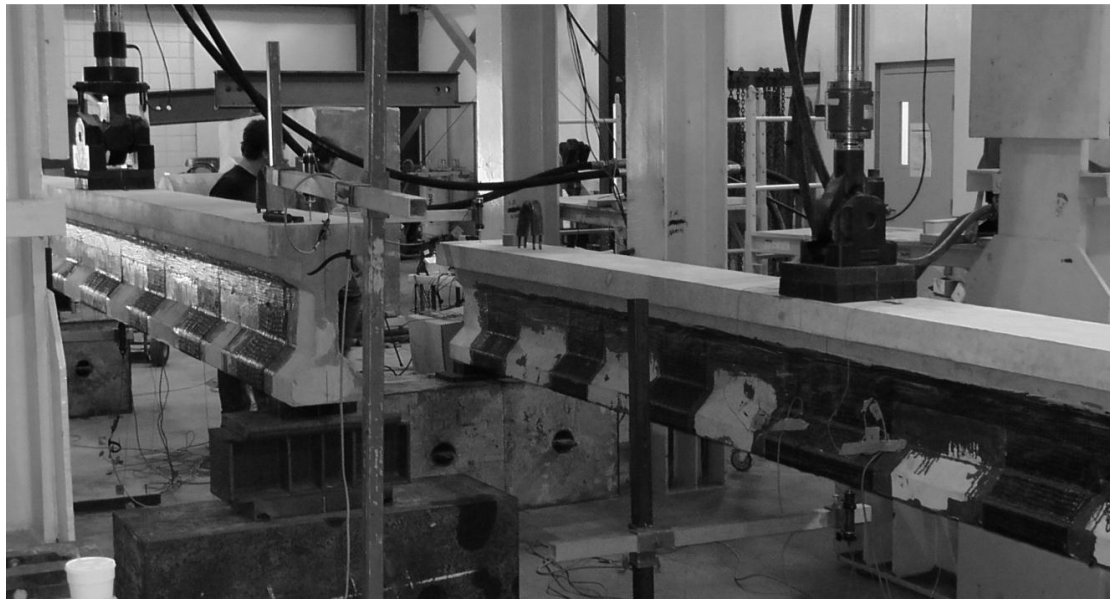
Figure 3-21: Testing Setup Schematic for Dynamically Loaded PSC Girders

configuration. The general placements of all measurement devices mentioned are also shown in Figure 3-20 and a photo is available in Figure 3-21.
